Manhole Inspection Summary

Manhole # S25EE_011MH

Insp Date: **10/11/07 9:10 AM**

Location Address: **1143 FREEMONT AVE**

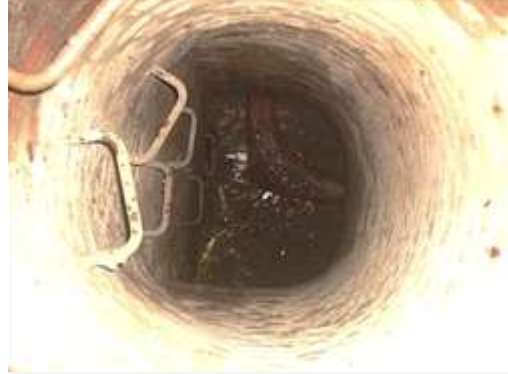
Top View

Barrel infiltration. Corroded steps.
Evidence of surcharge - Bench debris.

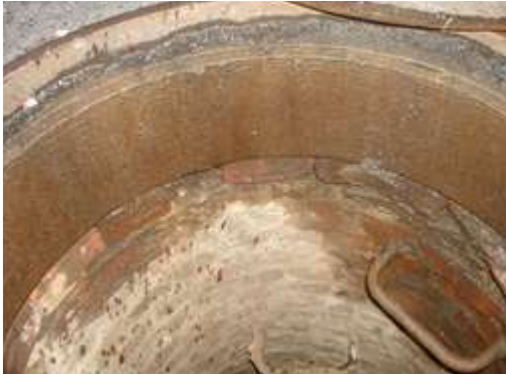
Defect

Frame leaks. Frame offset. Adjustment
deterioration and infiltration - other side.

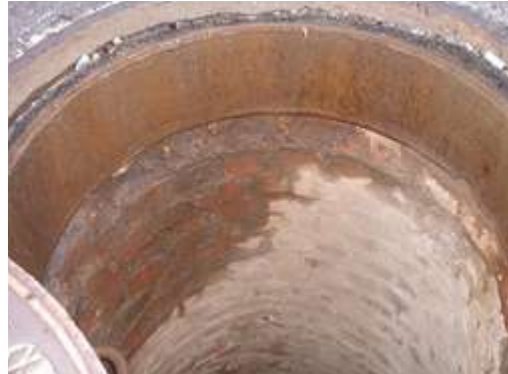
Defect

Frame leaks. Frame offset. Adjustment
deterioration and infiltration.

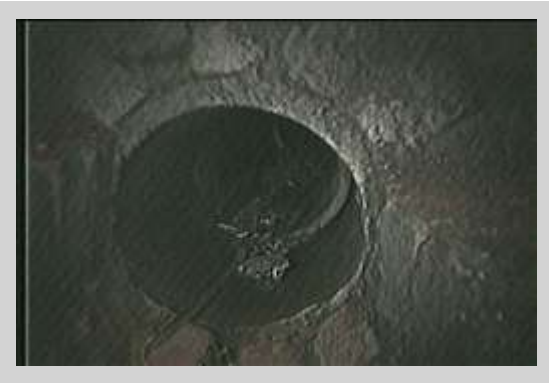
8 in. Circular Gravity Sewer Pipe Out @ 12 O'Clock

Deposits: ☐ None ☐ Mud ☐ Sludge ☒ **Debris** ☐ Grease

Silt Depth: **0** (in.) Deposits Extent: **Light**
